## SERVICE BULLETIN

No. TC-202

**SUBJECT:** Reel Cap Coming Off.  
**SUJET:** Le chapeau de bobine se dégage.

**DATE:** January 30, 1979 **MODEL(S):** TC-K96R

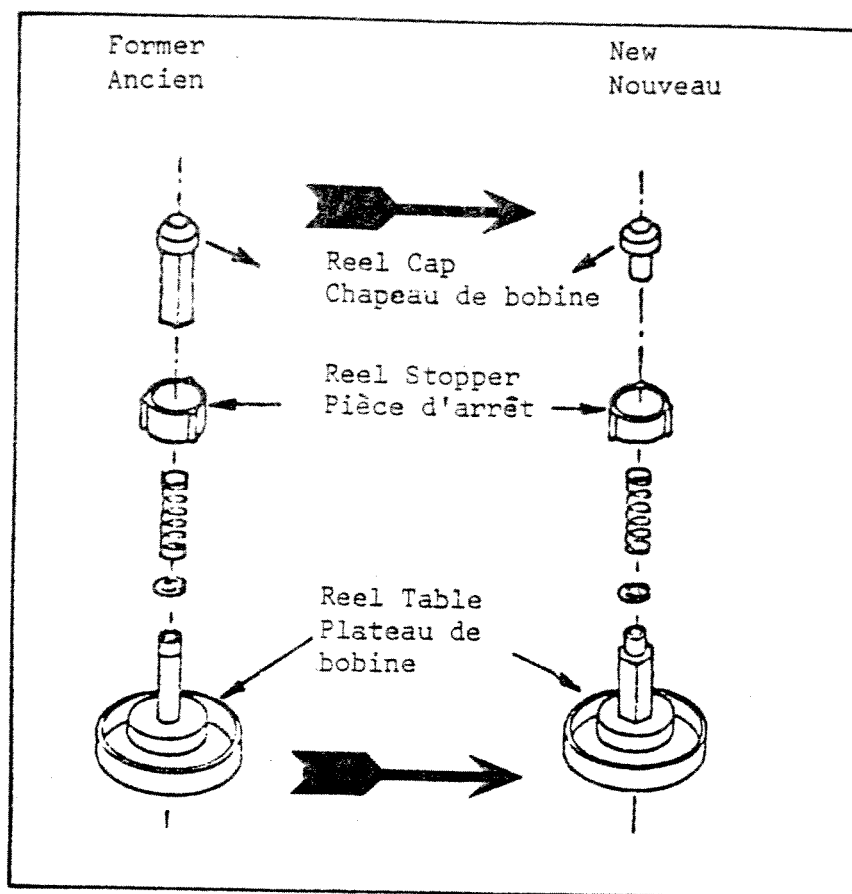
If the reel caps come loose due to insufficient pressure with the reel table, it is necessary to replace both Reel Table and Reel Cap with modified versions.

Both Take-up and Supply reel Tables should be replaced together; the reel stoppers can be re-used, but supply and take-up reel stoppers should not be switched.
