# Philco Predicta

## Repair Hints

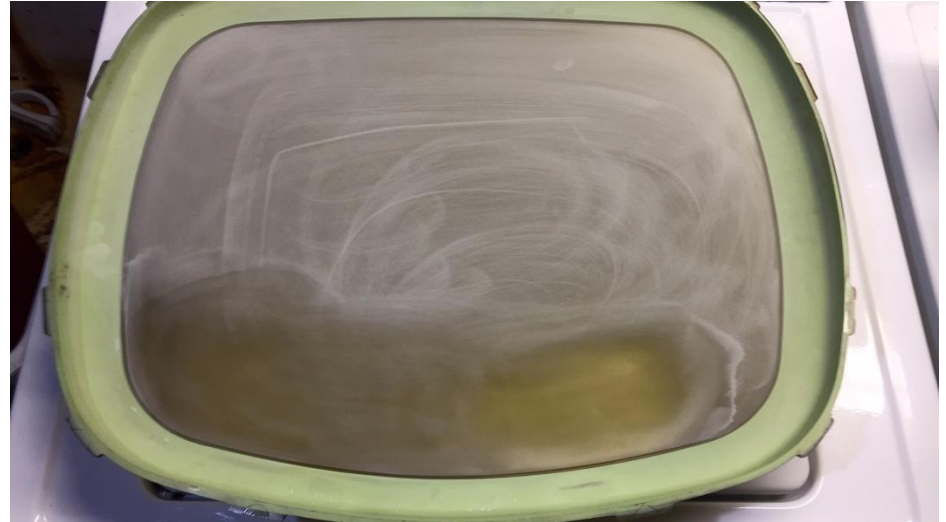
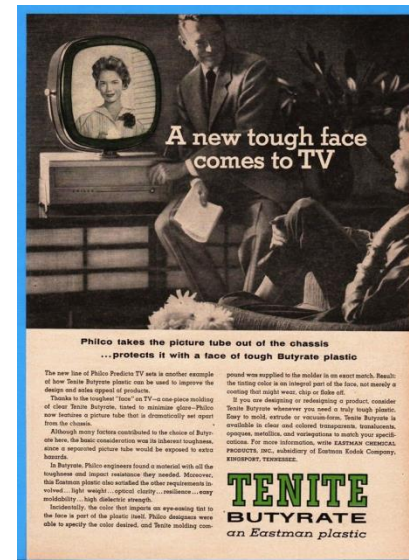
# Screen Covers

- Screen covers on 21" sets prone to material degradation, some more so than others
- Some covers develop a waxy, chalky buildup on both sides; tends to have bad smell (butyric acid)
- Made from "Tenite®" plastic
- Green tint is normal
- Degraded material can be removed via polishing
- 17" Models used different material; no oxidation issues

- The build-up of degraded material needs to be polished off
- A headlamp restoration kit works well
- After polishing, coat the cover with paste wax to help seal the plastic from the ambient air and slow further deterioration

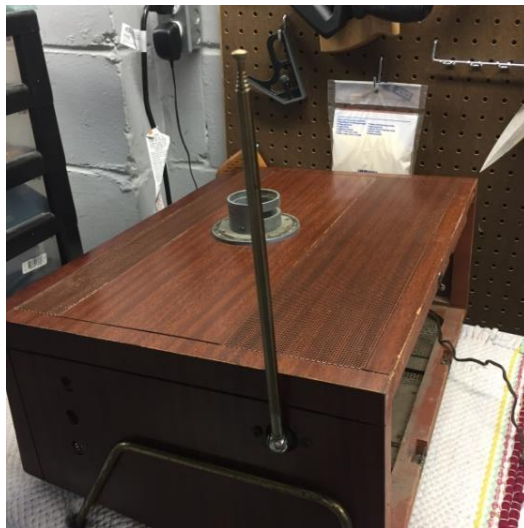
# Antennae

- Original telescoping antenna was designed to be stored internally
- Most antenna masts are broken off and missing
- Replacement can be fabricated and installed
- Pedestal and Continental used built-in antenna

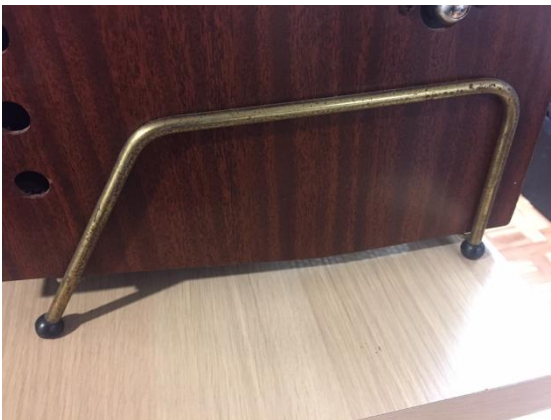
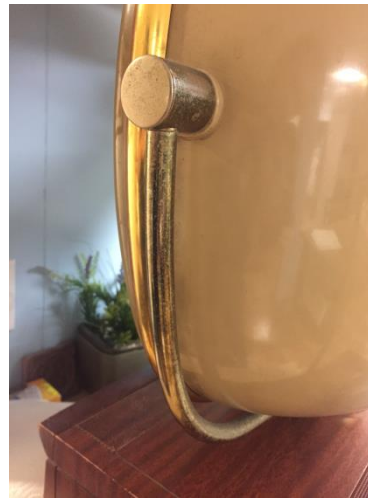
# Corrosion

- The decorative metal pieces on the CRT housing (side brackets, plugs and base) are made from steel with a thin brass plating that is prone to corrosion
- If the finish is in good condition, use care when polishing
- The front trim bar on the Holiday sets is anodized aluminum

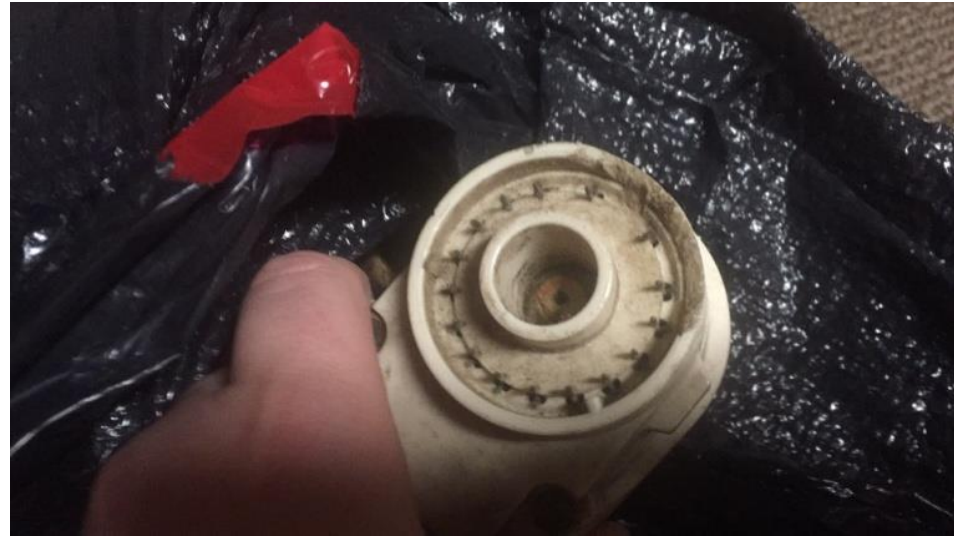
# Umbilical Cable Condition-Tandem

- Often the cable will have a sticky, filthy coating on it from plasticizer leaching out of the insulating jacket
- This can easily be cleaned up using citrus hand cleaner or acetone
- The cable should be checked for continuity in the case of broken wires (fatigue from rolling up cable, damage from walking on, etc.)
- Check for broken pins in socket
- Cable may be shortened slightly; but may cause picture issues (designed for length of cable)

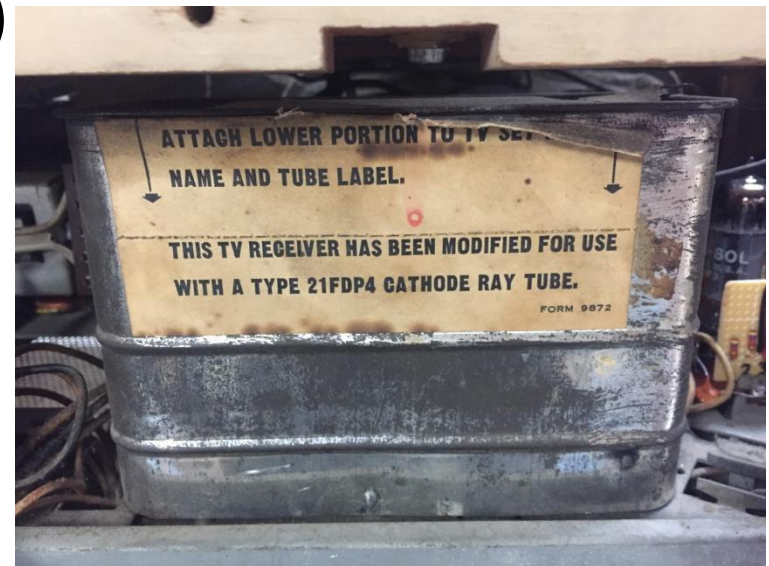
# Replacement CRT's

- 21" 21EAP4: Many replacements:
  - 21FDP4 (Most common)
  - 21FAP4
  - 21EVP4 (18 $\Omega$  shunt resistor needed for series string sets)
  - 21EMP4 (G1 and G2 swapped)
  - 21CEP4 (Longer neck, G1<->G2)
  - 21ESP4 (Longer neck, G1<->G2)

(When converting a set to use a 6.3V CRT, the last leg of the filament dropper resistor was fitted with a jumper wire. With higher modern line voltage, this isn't always necessary)

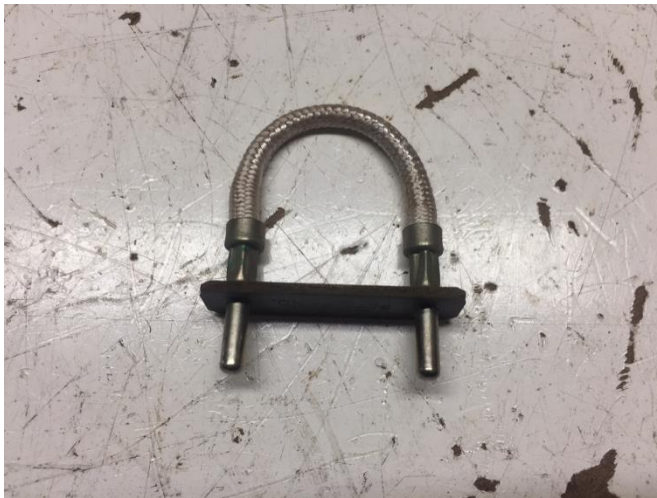
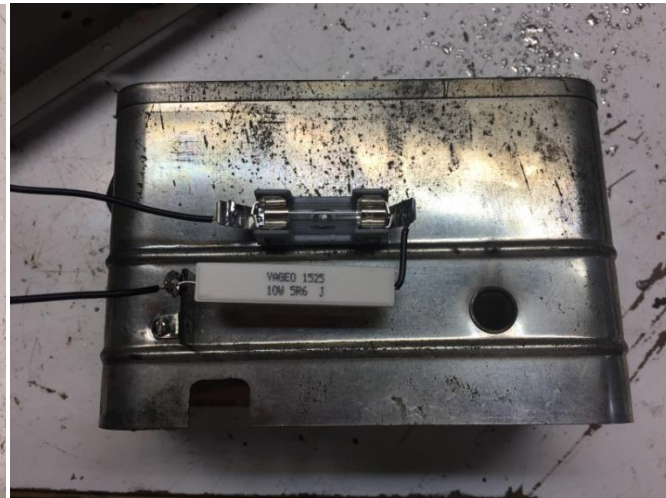
# Fused Resistor

- Protects power supply in case of short
- Limits current surge to PS diodes at switch-on
- Some are found defective or destroyed
- Can be substituted with separate  $5.6\Omega$  10W wirewound resistor and 1.0A Slow-blow fuse

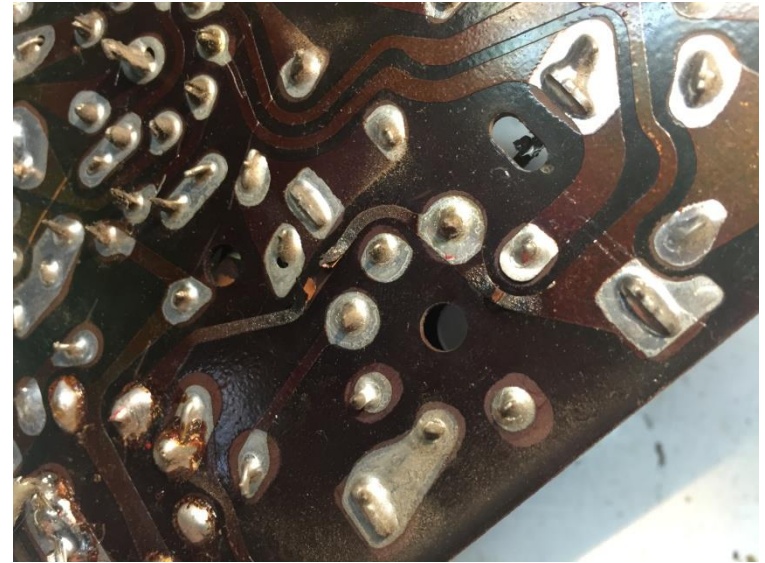
# Board Repair

- Due to heat build-up, boards can become brittle and/or traces can break
- Traces can be repaired by routing new leads along path of original trace
- Traces can lift with too much heat- use lowest iron setting that still yields good solder joints
- Re-flow solder on all connections
- Denatured alcohol can be used for board cleaning

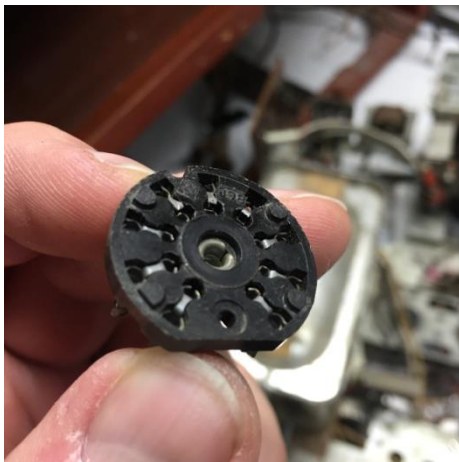
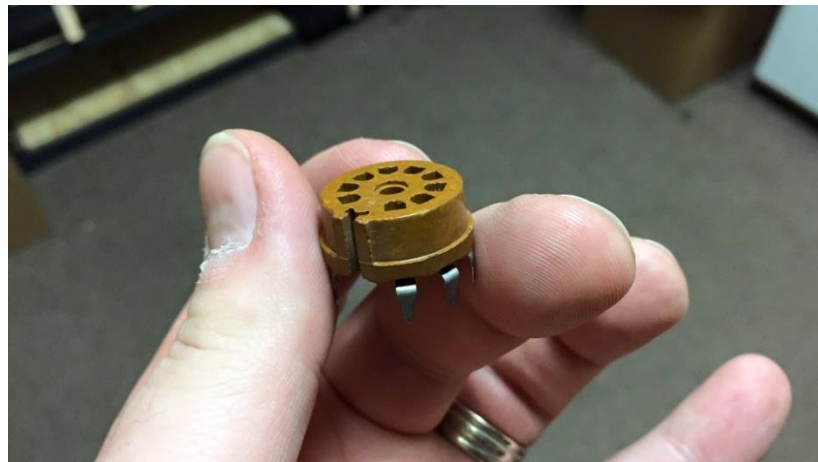
# Tube Sockets

- Due to nature of their design, tube sockets are prone to breakage of the socket pins
- These breakages are hard to see- each socket must be tested prior to reassembly
- Using a test socket gives an easy and reliable way to test each pin for continuity

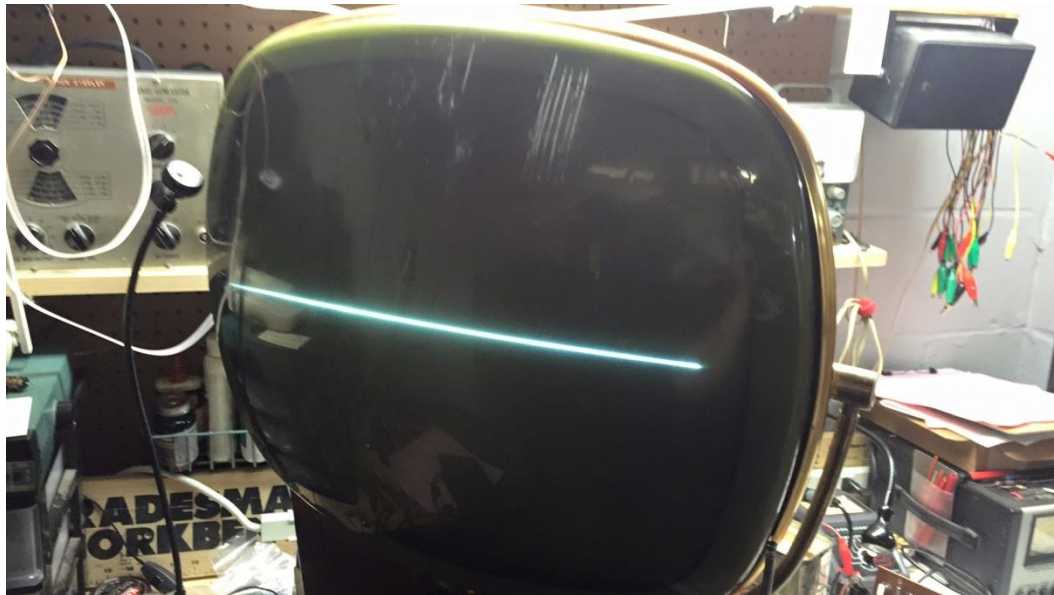
# Vertical Linearity Collapse

- Sometimes a set can display a flat horizontal line, despite being repaired
- In some cases the vertical linearity pot may be faulty, not allowing full raster deflection until near the end of travel

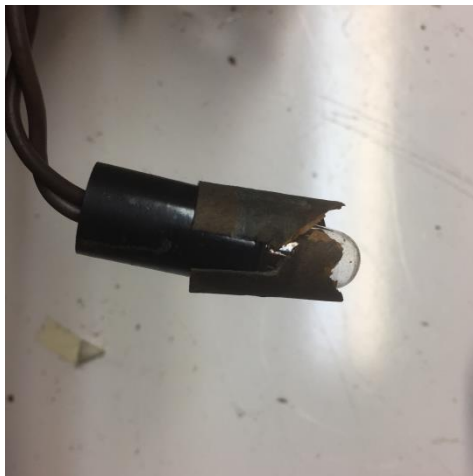
# Light Guide

- The pilot lamp is covered with a cardboard light guide
- The pilot lamp (#44) runs hot and over time the cardboard deteriorates and crumbles
- A ½" ID model rocket body tube can be used as a replacement

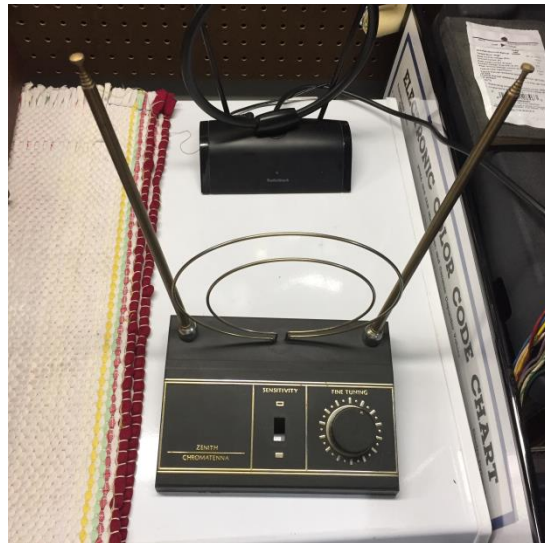
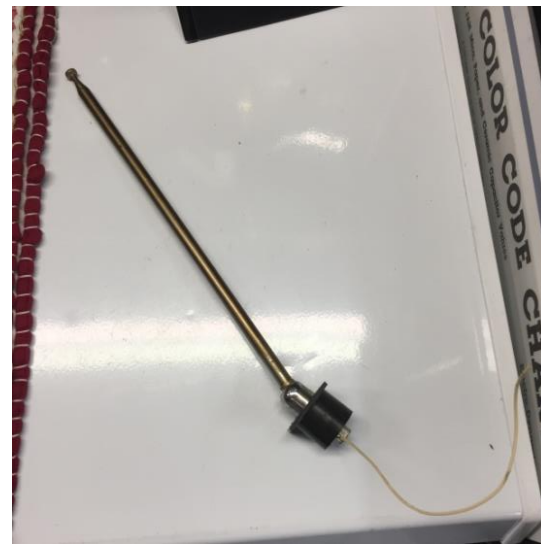
# Antenna

- A telescoping brass swivel-type antenna may be substituted for a missing original
- The Zenith Chromatenna is a good source
- The antenna can be cut out and mounted with the original hardware

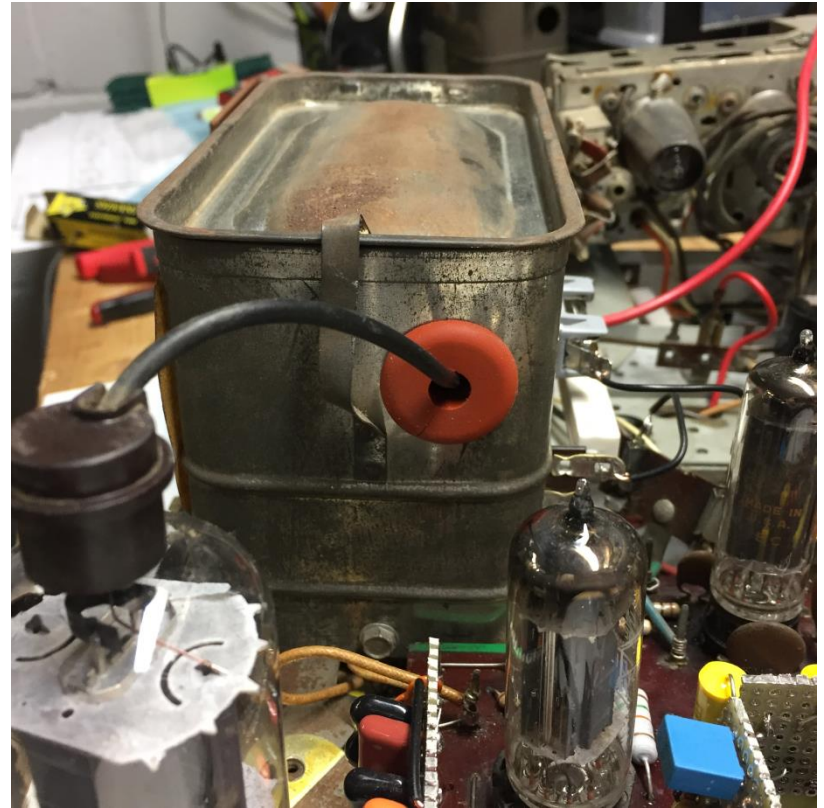
# HOT Wire Protection

- There is a fish paper holder to keep the HOT plate lead from chafing on the edge of the hole in the flyback housing
- Often this holder has cracked and fallen apart
- A silicone grommet can be used
- Good up to 500°F; available from McMaster-Carr

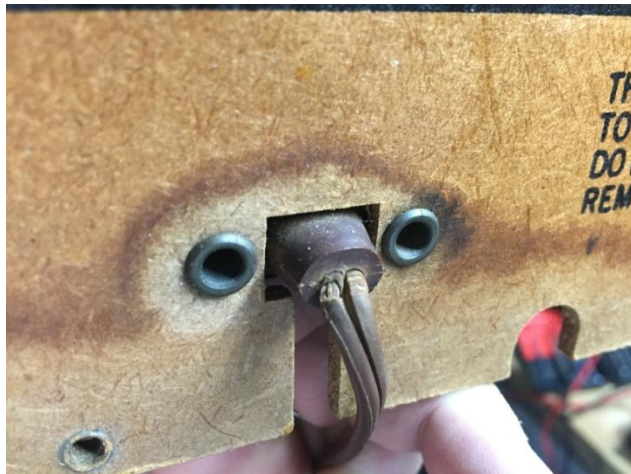
# Cord Replacement

- Units use non-polarized cheater cord; 21" models use "eared" versions
- Replacement cord ears can be heated and slipped over original rivets
- If rivets are missing, flanged aluminum fasteners can be substituted

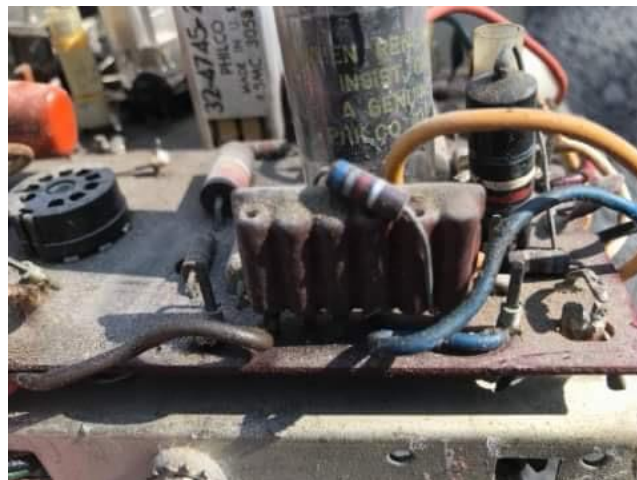
# Sync Network Resistor

- Some Tandem models have a sync separator network with an extra resistor soldered onto it
- This was a factory modification- not a field repair
- The part numbers are different between the Holiday and Tandem- this is a Holiday network altered to work in a Tandem set

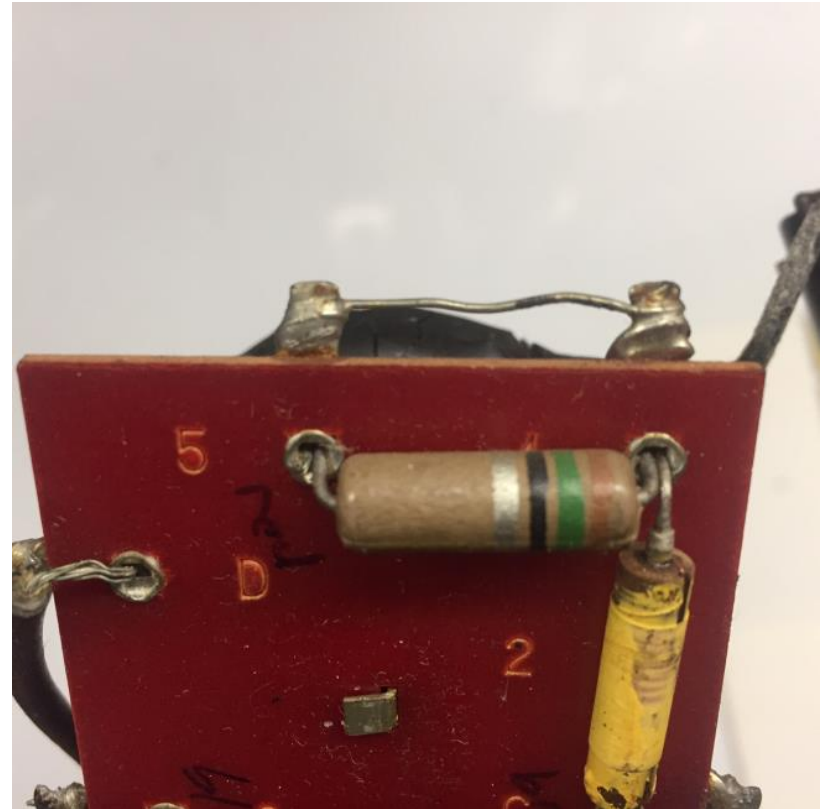
# Flyback Jumper

- On top of the flyback terminal board there is a 2 Watt 15 $\Omega$  resistor
- In most instances this resistor will have a jumper wire across it
- This is a factory modification

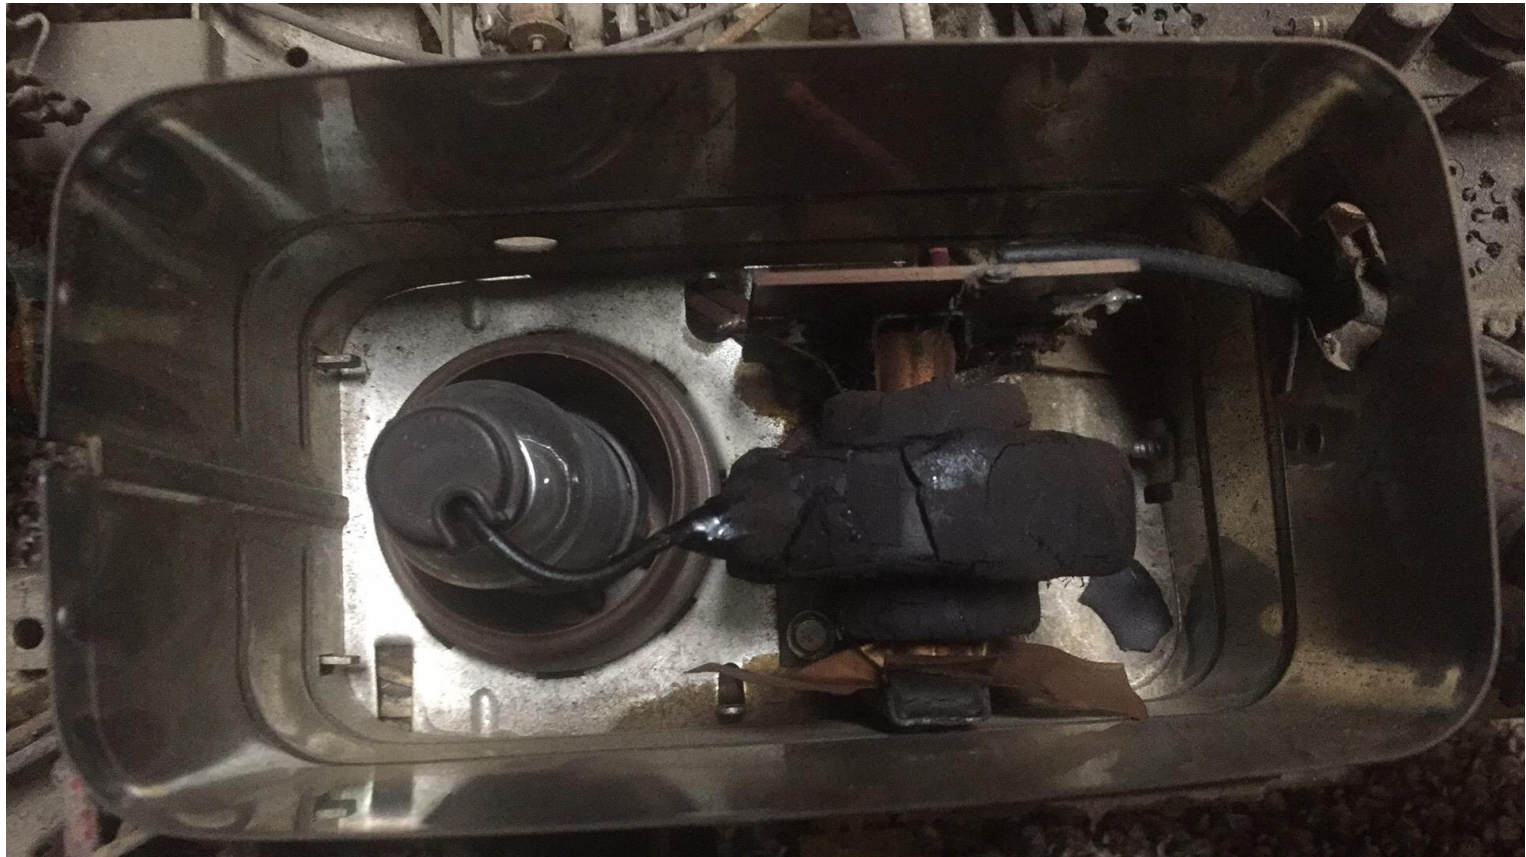
# Flyback Fins (Tandem)

While similar to the 9L37 type, this HCT has cooling fins  
They look homemade, but they are factory
