# MITEL SX10 & SX10E

**PXML No. 75 (SX10) and 79 (SX10E)**

The [Mitel](#) SX10 (shown below with console) and SX10E (shown right with superset 4) is a LD/MF analogue switch with a maximum configuration of 8+24 (SX10) and 8+32 or 8+24 (SX10E). The SX10 was introduced around 1982, used a Remote Display Unit instead of a console (introduced late 1983) and had a metal cover surrounding the PSU and card mounting. The SX10E superseded the SX10 in 1985, and was fitted with a plastic, ribbed cover and used software variant 143, which supported supersets (up to 24), call logging and 60 memory abbreviated dialling. Both variants have 8 speech paths and system architecture is Stored Programme Control (SPC).

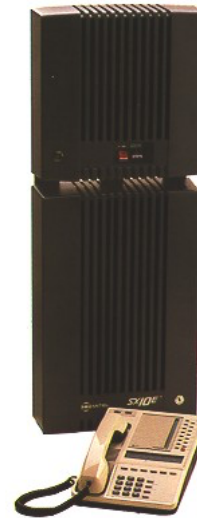
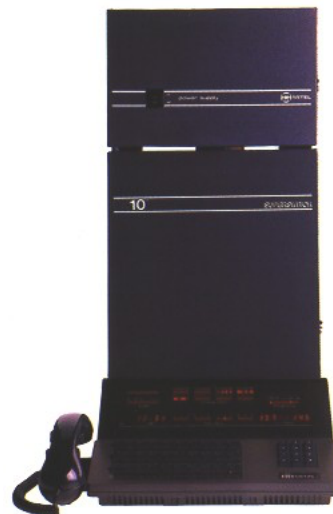
## CONFIGURATION

The system cabinet fixes to the wall and uses a separate console that can be positioned away from the cabinet. This console is also used by the Mitel SX20. The Master Card (CPU board) has 8 extension ports and provision for 2 trunk cards. Additional ports are added by installing a 8, 16 or 24 port extension cards. These cards have provision for 2 trunk or 2 private circuit cards. A Remote Display Unit must be fitted for programming purposes, if no console is provided. Featurephones can only be used on 143 variants with Mastercard 2.

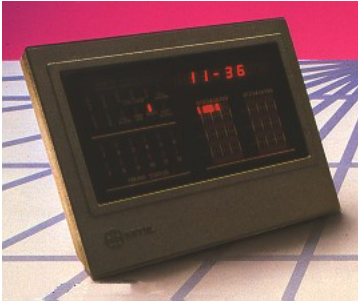
**REMOTE DISPLAY UNIT**

The Remote Display Unit is supplied as a kit that comprises of two American style jacks and two connection cords. A two pair cable is run between the two jack sockets. One cord plugs into the Remote Display Unit and the other end plugs into the CCU motherboard. The Display Unit is shown to the right and the table below advises on how to wire the unit.
